Flourtown Country Club

Judy Stern Goldstein, ASLA, R.L.A.
Boucher & James, Inc.
Fountainview Professional Building
1456 Ferry Road
Building 500
Doylestown, PA 18901

Springfield Township
1510 Paper Mill Road
Wyndmoor, PA 19038

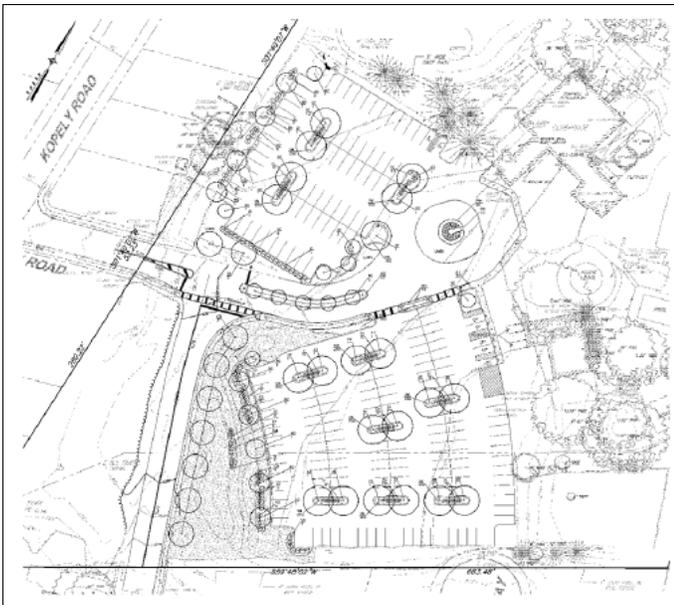
The Landscape Plan for the redesigned country club

Springfield Township was very receptive to these ideas and plans and designs were prepared to meet their needs. A new entry sequence was designed to complement and enhance the new architectural features proposed and to direct the public to the proper entrance areas for their functions. Design continued for the new parking area and emphasis was placed on circulation and safety for both pedestrian and vehicular traffic. The new parking lot and entry area was designed to include planted islands that serve several functions. They serve to separate and direct the traffic; they provide areas for native plantings; and they provide the opportunity to plant vegetation to provide shade and to mitigate the affects of the sun beating down on the paved areas.

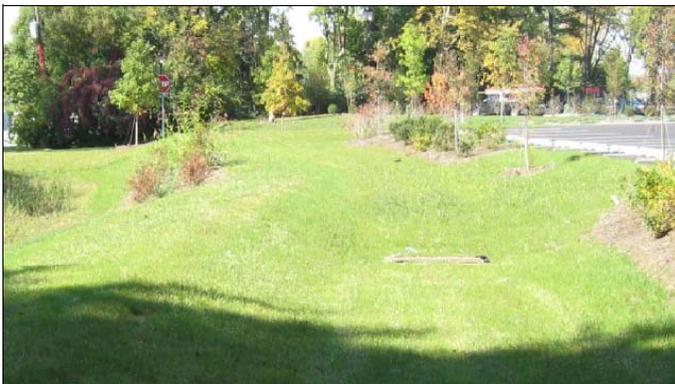
Soil quality did not allow for infiltration beds, so an informal solution was designed, using native plants

The design solution consisted of a two-tiered concept of informal stormwater infiltration with significant soils amendment and the planting of a conservation seed mix. Landscaping (with native vegetation) was proposed along parking areas to reduce the rate of run-off and to filter pollutants such as sediment and petroleum hydrocarbons from the run-off. The upper tier was designed to take the first flush of stormwater. It would then reduce the rate of the stormwater and permit sediment and pollutants to settle prior to spilling over into the lower tier. Each tier was designed to permit marginal infiltration (as much as the soils would permit). The cumulative effect of the two tiers and the vegetation was designed to provide dissipation of stormwater run-off and increased quality of run-off beyond what currently exists at the site and beyond what would exist if overland flows were permitted to occur unabated, even with the reduced paving and new parking lot design.

- Standing water was evident in the two tiers during and after storm events. Unfortunately, the soils were not able to absorb/infiltrate as much as the testing indicated would be possible and standing water for extended periods of time was not acceptable to the residents or the community. To address this issue, stone beds were created to remove standing water from the surface and detain it underground while the infiltration process occurred, at a slower rate. The stone beds under the tier gardens were then connected underground to permit overflow from the upper bed to enter the lower bed just as surface grading had previously permitted.

- After the first set of modifications, the tier gardens were able to drain totally in three to four days. Neighbors expressed concern over any standing water, even though it was infiltrating, and seemed to base many of their concerns on fear of the spread of the West Nile Virus. In response to these concerns, the Township installed a drain pipe to permit water in the upper surface of the garden/bed to drain to the curb line.

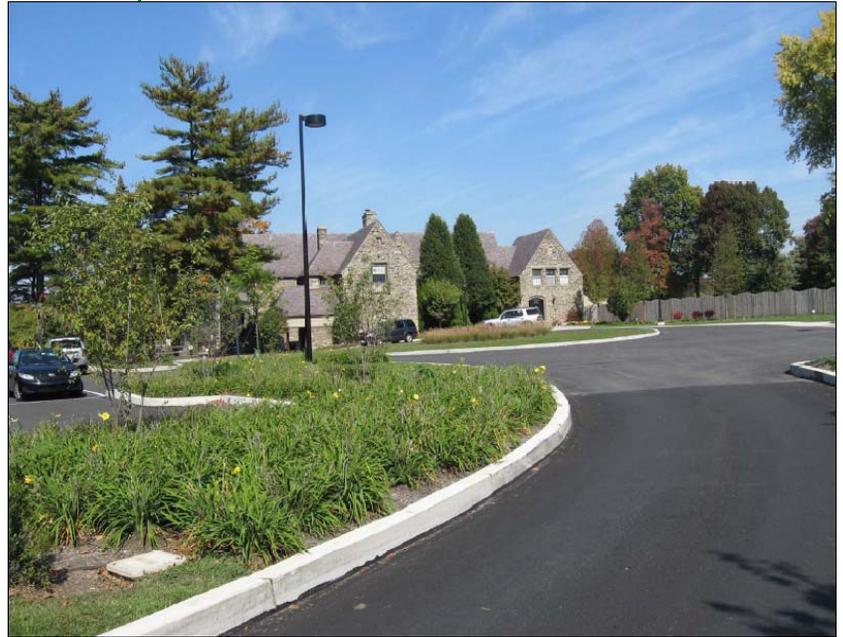
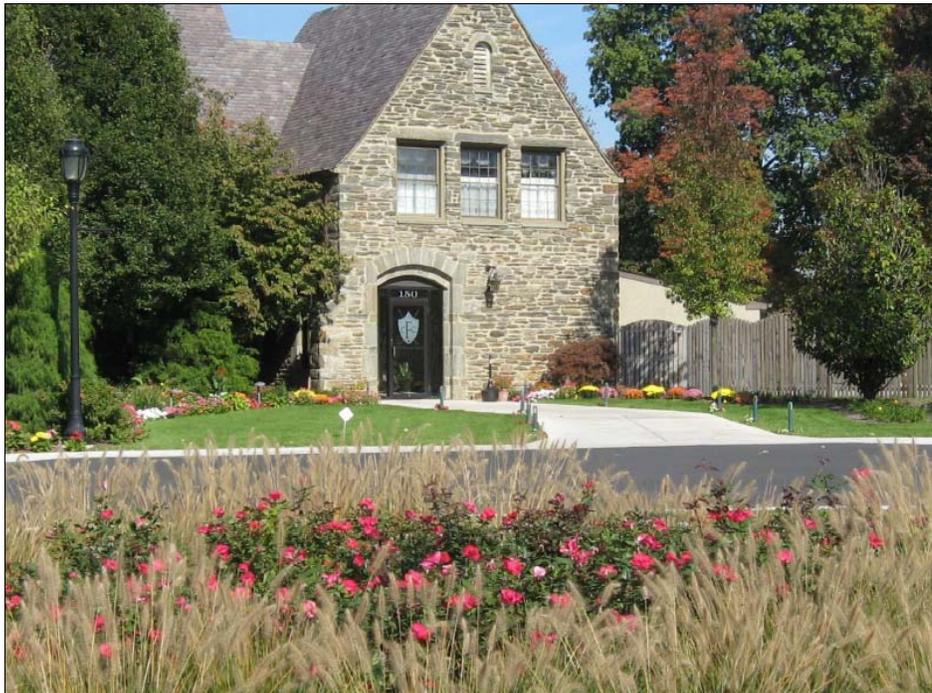
The parking lot and entrance to the country club are now more visually appealing and sustainable, in addition to being safer for pedestrians and drivers

- Reduced paving and impervious surfaces
- Use of “tiered gardens” to slow the rate of runoff
- Use of native vegetation to filter sediments and pollutants from the stormwater
- Use of graded landforms (a small berm between the upper and lower tier) to force water to settle and cleanse prior overtopping the berm and continuing down to the lower tier
- Shade trees were planted along the perimeter of the parking and in islands to provide shade and cool the pavement, thereby improving the microclimate of the site
- Use of native vegetation that is suited to the area and will require less maintenance than exotic species

The end result is the Township now has an attractive, functional and more sustainable entrance and parking area for the Flourtown Country Club. The primary needs of improving pedestrian and vehicular safety were met with an attractive design that also was able to include sustainable elements.
