Pennsburg Nature Preserve

John W. Munro
Munro Ecological Services, Inc.
990 Old Sumneytown Pike
Harleysville, PA 19438

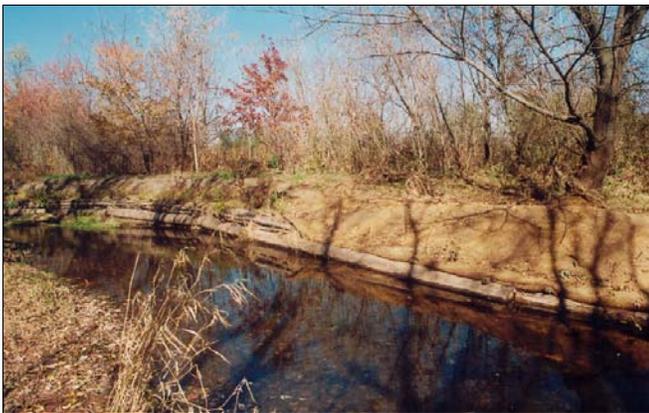
Macoby Creek, which runs through the park, suffered from steep eroding banks

The consultant drew up a **concept plan** that includes:

- 490 feet of streambank stabilization using MES structural fascines and timber crib face bio-structural design (*these are structures with specifications designed by MES staff*)
- Series of 4 stream sills, to begin elevating the incised channel back to its pre-disturbance level
- Planting of two acres of floodplain forest where golf course mowing had recently ceased
- Planting a series of 15 native shrub and tree patches in the existing mowed lawn to: provide visual variety in the stark lawn setting; include habitat for native birds and small animals; cluster examples of native riparian shrub species; and reduce mowing requirements
- A walking trail around the meadow and along the stream

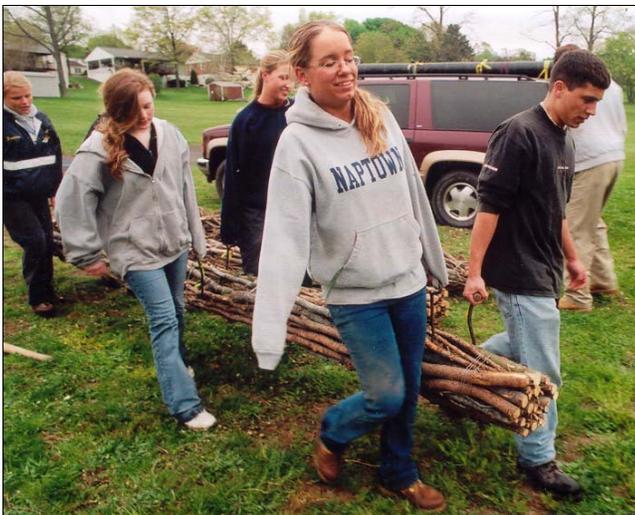
These middle school student volunteers from the Upper Perkiomen School District carried structural fascines to Macoby Creek in order to help stabilize the banks

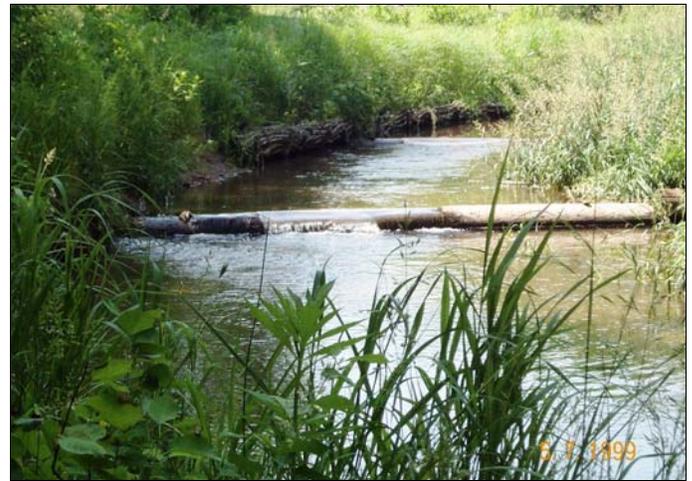
A stream sill and planted structural fascines

The stream sills- The sills began to work immediately upon installation and have performed the intended function of re-accumulating gravel beds in the stream bed. The previous stream scouring and incision (down cutting) were the result of increased flood flows resultant from development of the headwaters.

It is estimated that the stream incision in the park was at least 12 inches and as much as 24 inches in various stream segments in the park. The stream water level has now been raised by 8 to 12 inches and the areas behind the sills have filled in with gravel sufficiently to provide spawning and macro-invertebrate habitat that had been lost (in some areas the scouring had cut to bedrock).

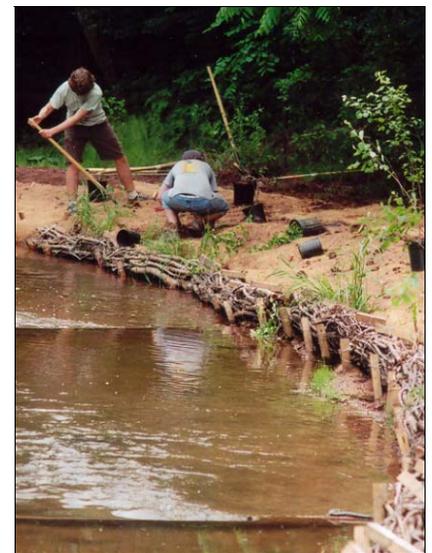
Volunteers planting native trees and shrubs in the riparian buffer. Structural fascines line the creek edge

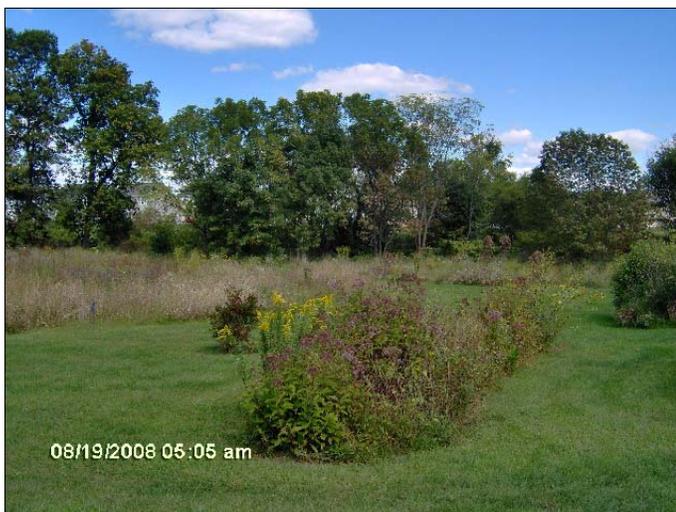
Warm season grass meadow and native flower plantings

The meadow - The tallgrass meadow installation was finally finished in 2009, after the first seeding was followed the next day by a very heavy rain and flooding of most of the meadow with consequent loss of most of the new seed. After the first year, and as a result of an underperforming meadow and uninformed borough mowing staff, large sections of the designated meadow area were mowed to one inch height, killing off some of the struggling native plants. This discovery provided the opportunity to firmly mark the edges of the meadow and provide explicit instruction to mowing personnel that has prevented excessive mowing since that time.

The first growing season was mostly in drought condition, but during several Earth Day events in following years, in which local volunteers planted Borough-purchased seed and grass plugs, the meadow finally grew thickly and tall.

The variety of native species planted include 10 sedge and rush species, 15 species of meadow grasses and flowering forbs, 11 species of riparian shrubs as cuttings and tubelings, 14 riparian shrub species and 9 tree species.
