2. Emmaus Community Park Stream Restoration – Lehigh County, Pennsylvania

Rebecca Hayden, Watershed Specialist
Lehigh County Conservation District
Lehigh County Agricultural Center, Suite 102
4184 Dorney Park Road, Allentown, PA 18104

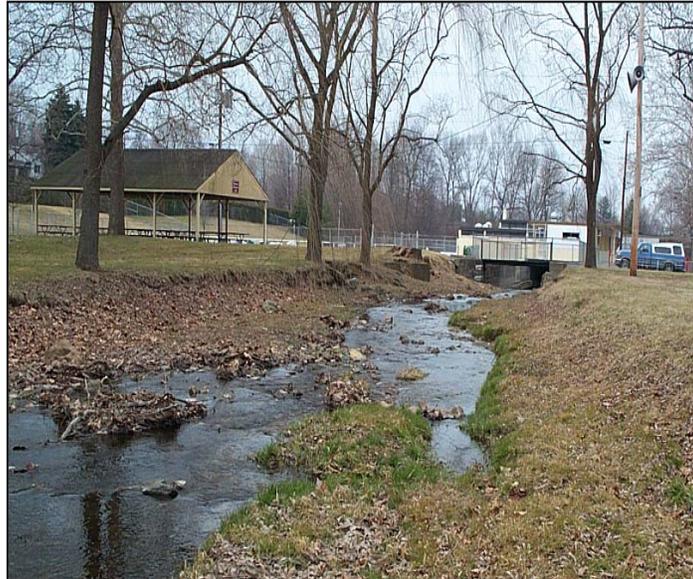
**Community Park
before the stream
bank improvements.
Note the erosion and
lack of vegetation.**

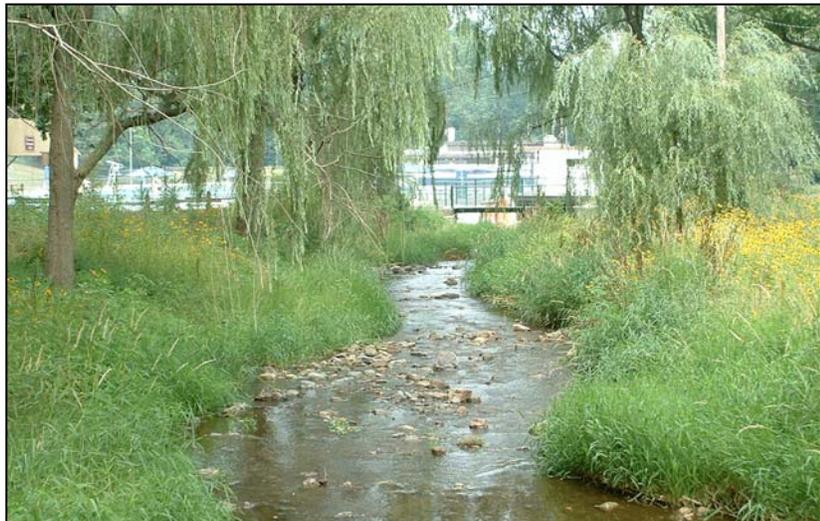
Community Park after the restoration. Note the stabilized banks and abundance of vegetation.
